**REPAIRED GLASS COCKPIT  
W/WS SYSTEM SAFETY REPORT**

**RICHARD J. OLSON**

**BATTELLE  
505 KING AVENUE  
COLUMBUS, OH 43201**

**SYSTEMS SAFETY HAZARDS ANALYSIS REPORT FOR 09/91 - 2/96  
CONTRACT NUMBER FO9603-90-D-2217-SD02**

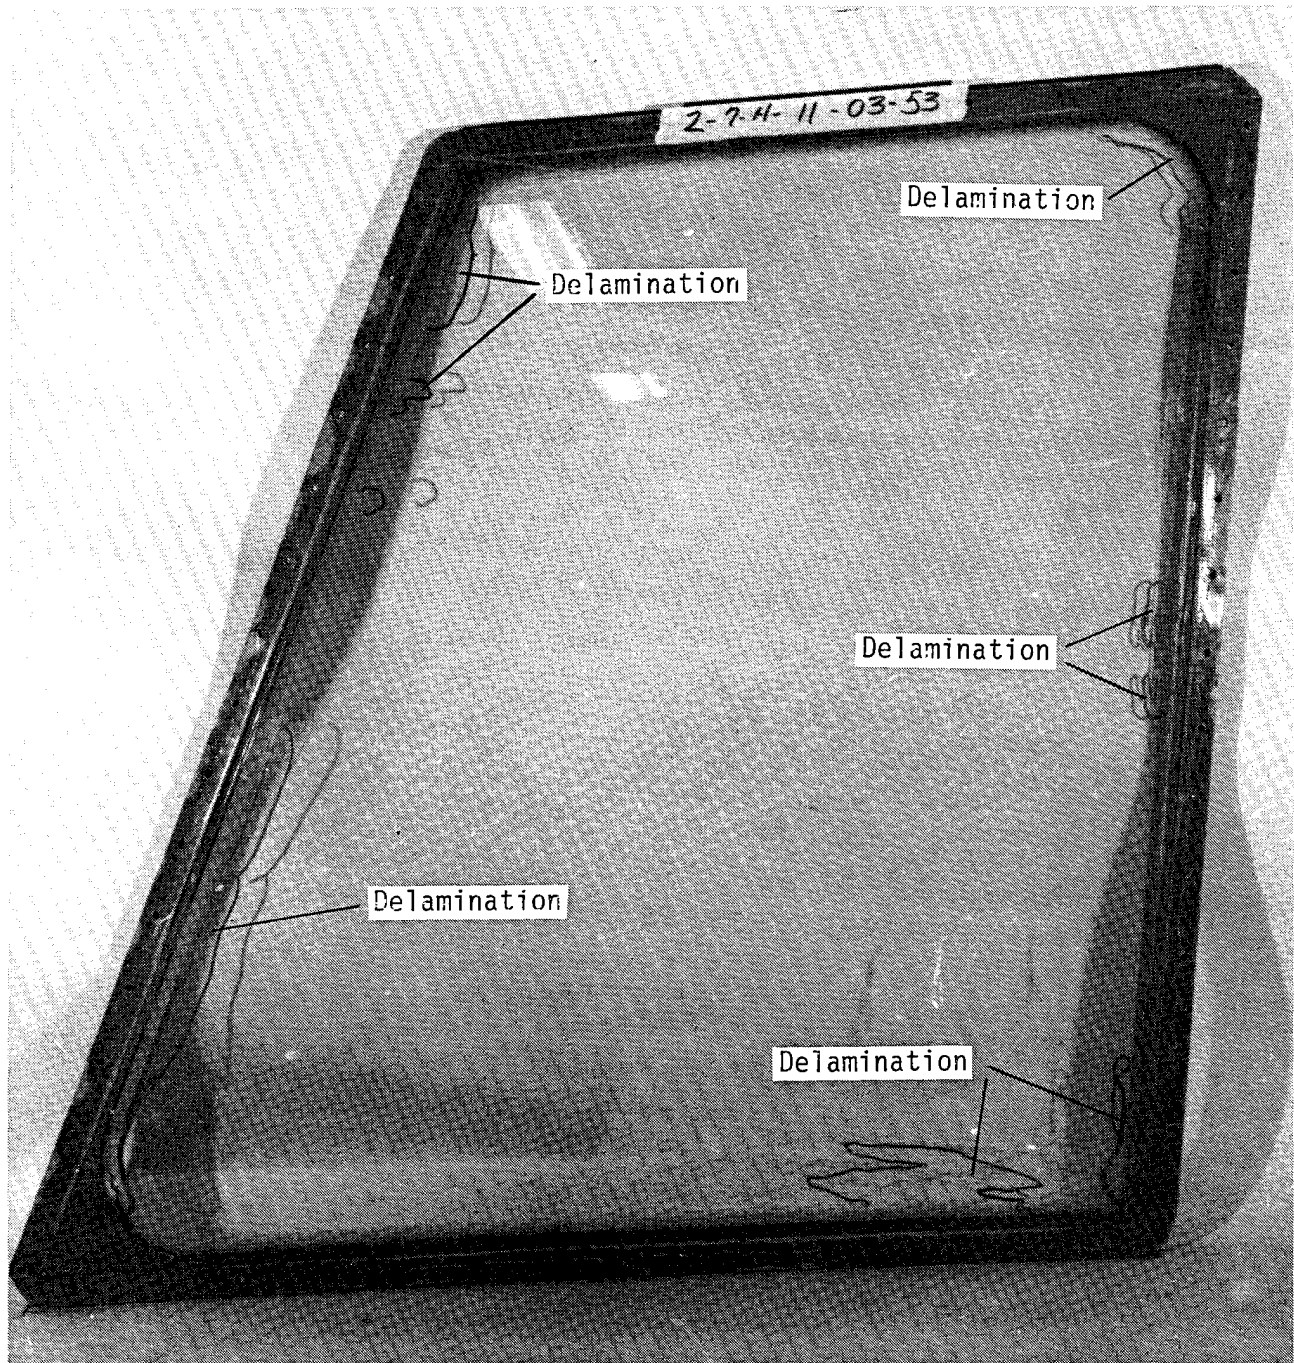
The results of the pressure integrity testing are summarized in Tables 3.13 and 3.14. None of the W/WS, repaired, not repaired, or new, exhibited any catastrophic failures. Some of the repaired W/WS did experience delaminations, and evidence of delamination was detected in the new B-52 W/WS. Figure 3.1 shows the worst delamination that occurred in

any of the W/WS tested. In this figure, the edge of the delamination has been outlined with a black marker. None of the W/WS exhibited delamination that would cause the pilot to be unable to see through the W/WS.

**Figure 3.1 Worst Delamination Observed in all Pressure/Thermal Cycle Tests  
(B-52 #1 W/WS, S/N 7-H-11-03-53)**

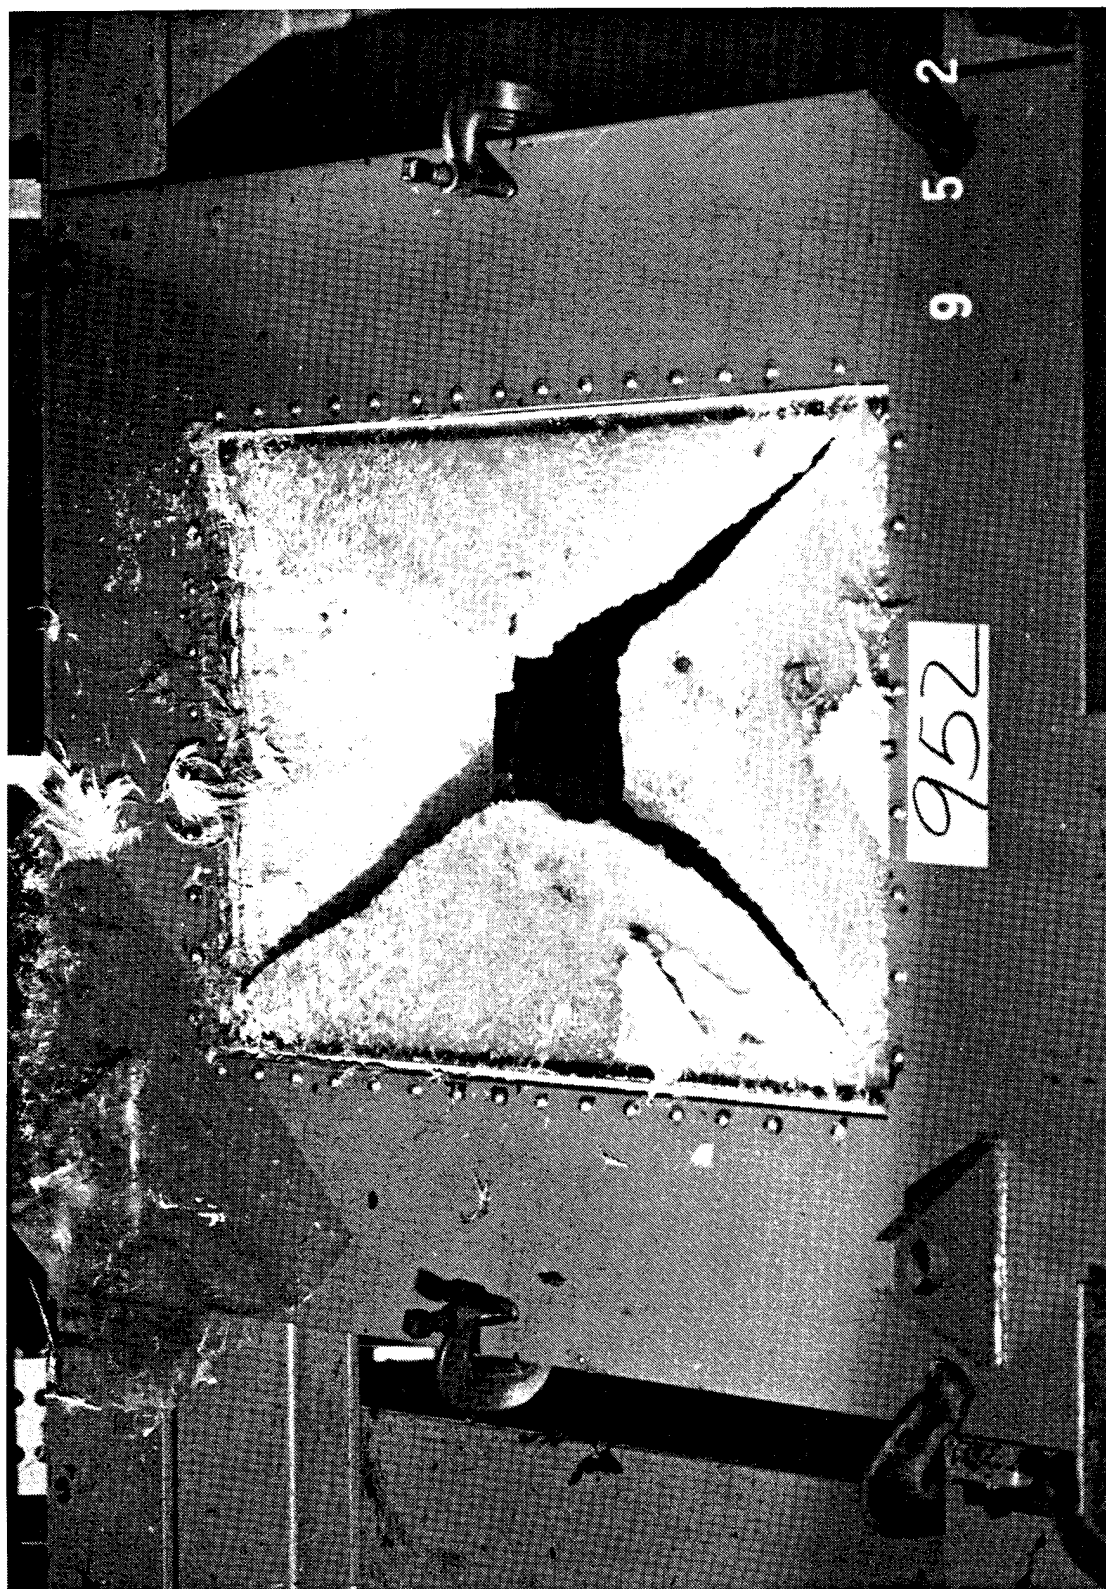
Figure 3.2 Catastrophic W/WS Failure From a 4-Pound Bird Impact at 250 Knots  
(B-52 #1 W/WS, S/N 86-H-04-28-693)

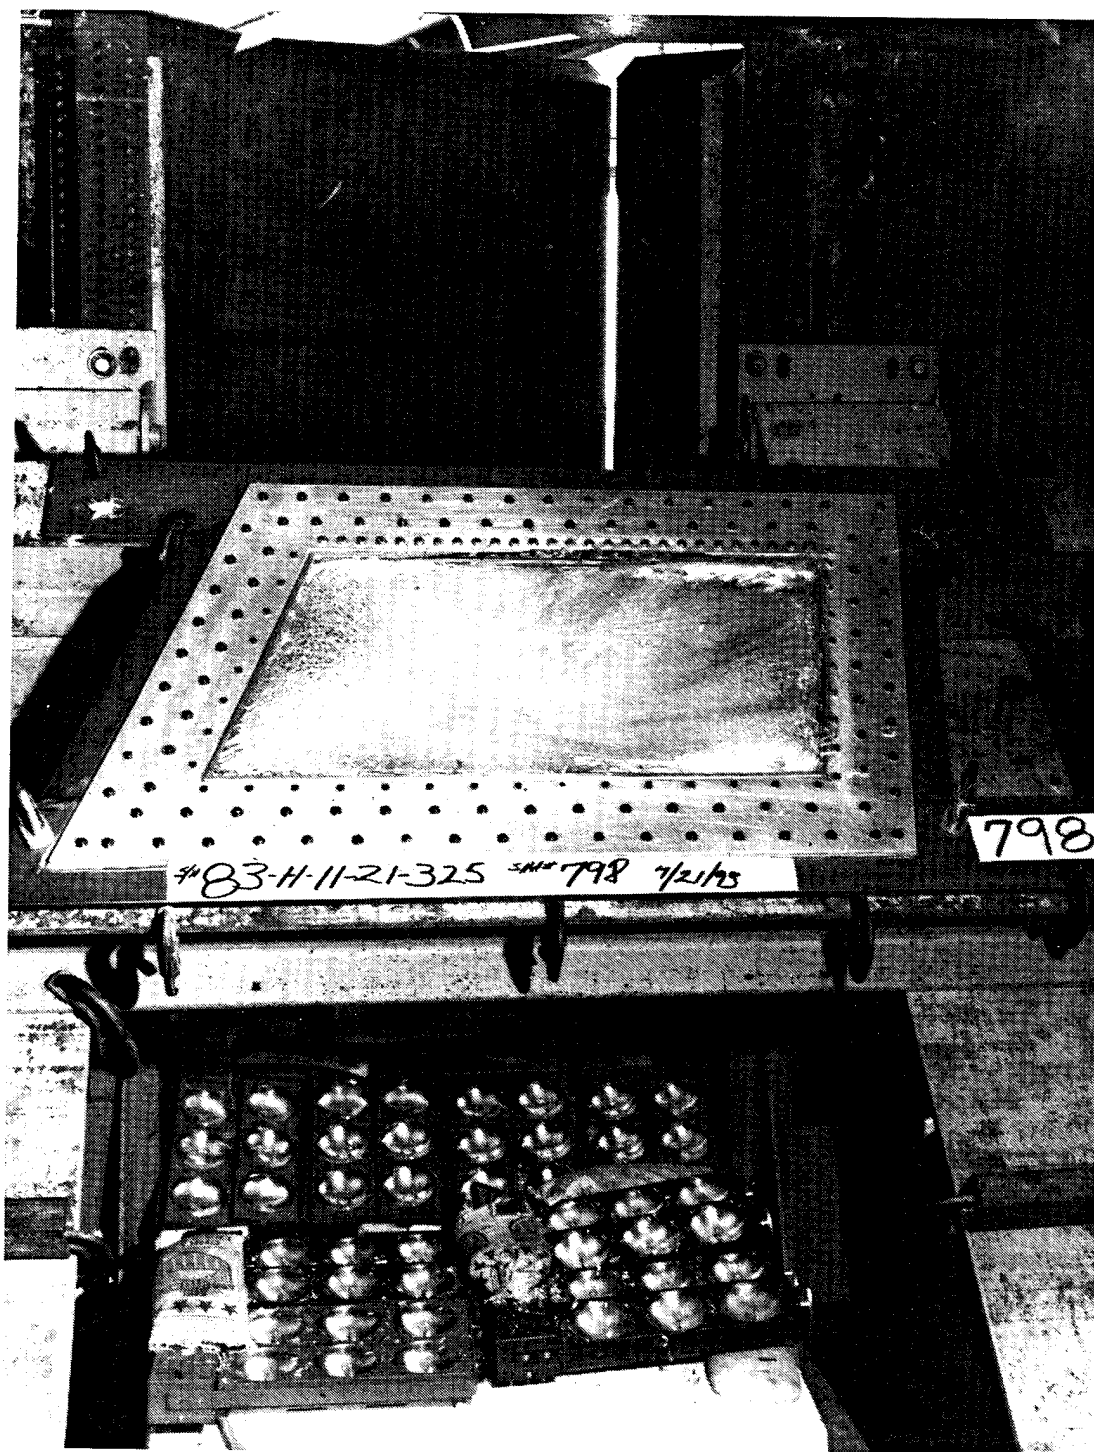
Figure 3.3 Both Glass Plies Failure From a 4-Pound Bird Impact at 250 Knots  
(C/KC-135 #1 W/WS, S/N 83-H-11-21-325)

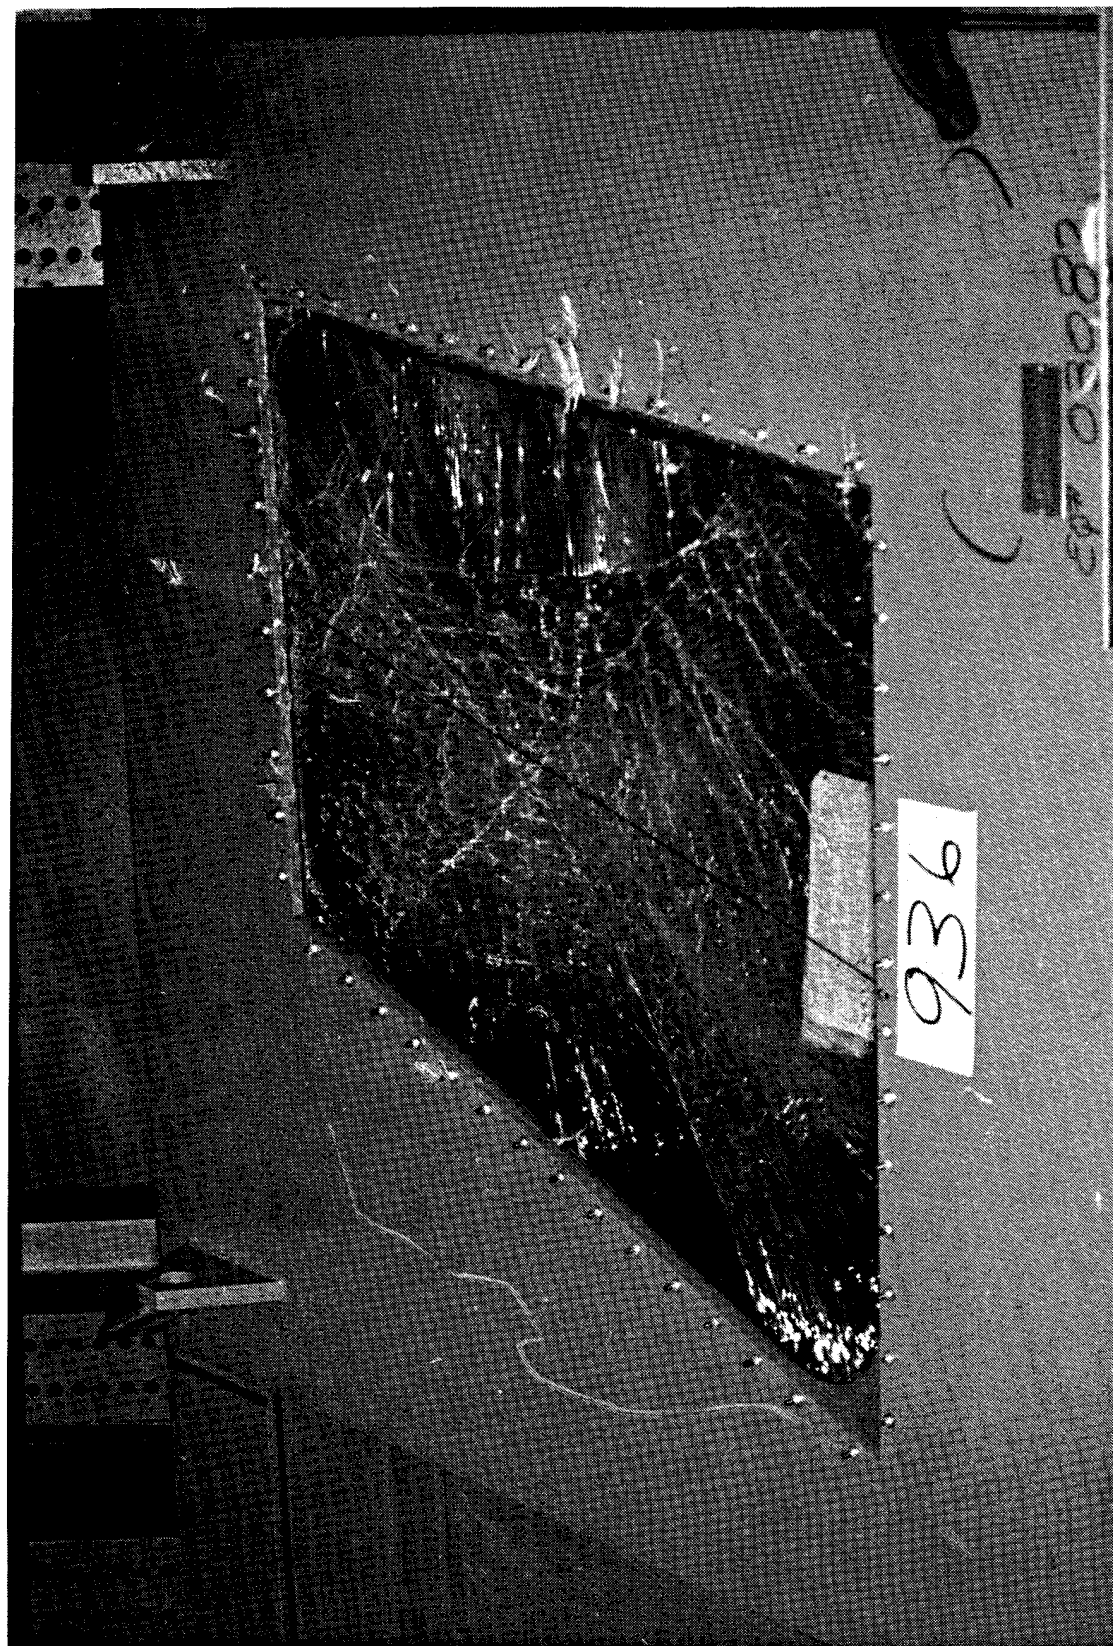
Figure 3.4 Broken Outboard Glass Ply Failure From a 4-Pound Bird Impact at 300 Knots  
(B-52 #2 W/WS, S/N 5-H-3-20-17)
